Technische Universität München  
Prüfamt für Verkehrswegebau | Baumbachstraße 7 | 81245 München

Munich, 16. November 2017

**Subject: Investigation of corrosion durability of dowels and tie bars in salt-spray test according to EN ISO 9227:2012**

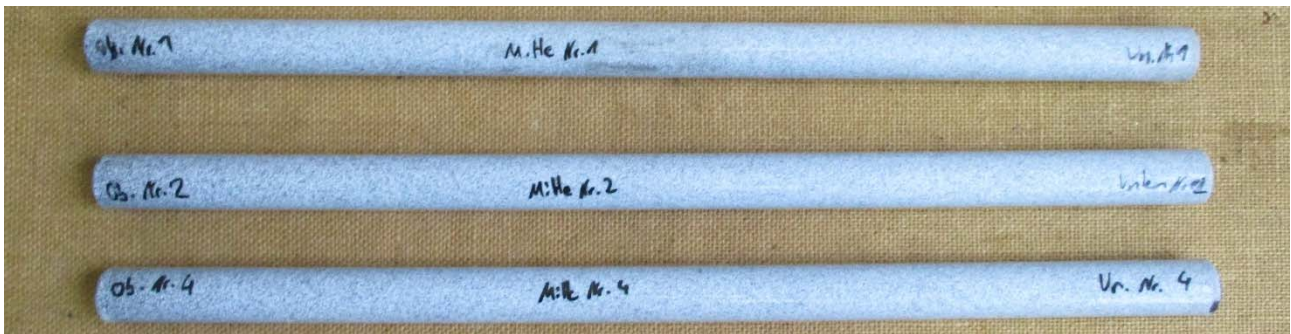
**Picture 1: Plastic coated surface of investigated dowels before corrosion testing.**

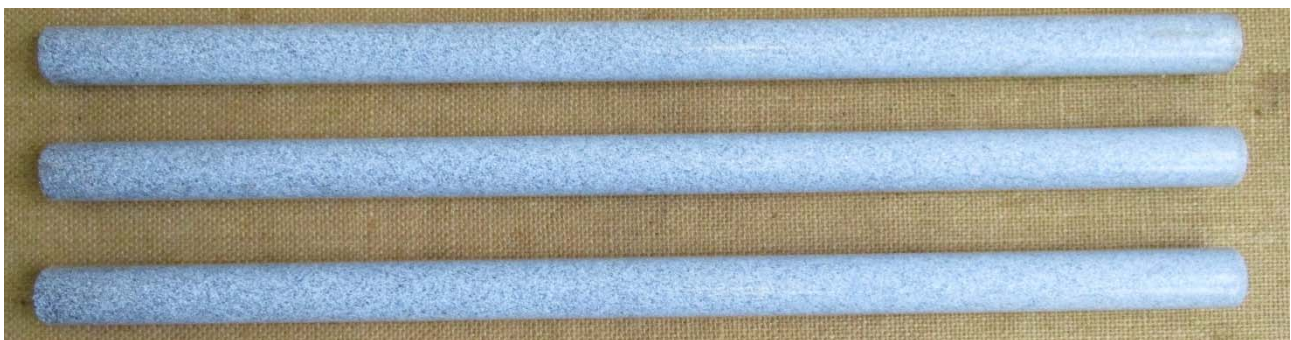
**Picture 2: Opposite surface of investigated dowels before corrosion testing.**

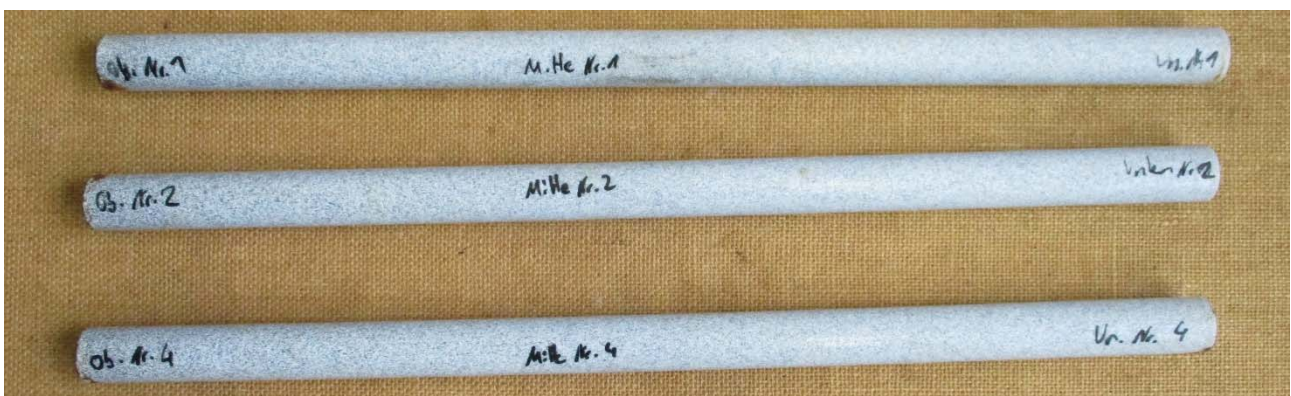
After 240 hours of salt-spray, plastic coating of **dowels** show an effective protection against corrosion. No rust spots were observed at the total regarded area of plastic coating on lateral surface. See pictures 1 and 2 for view of dowels before testing and pictures 3 and 4 for conditions after corrosion test.

**Picture 3: Plastic coated surface of dowels does not show any rust in regarded area of lateral surface after 240 hours at neural salt-spray.**

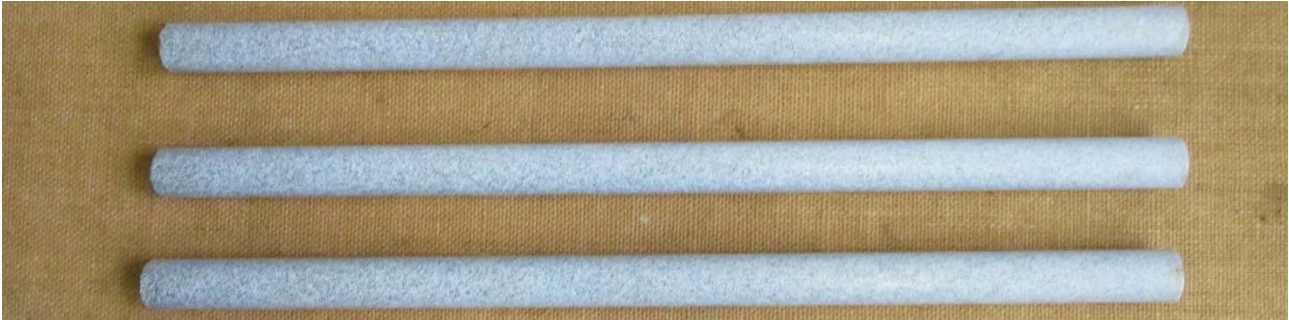
**Picture 4: Opposite plastic coated surface of dowels without any rust in regarded area of lateral surface after 240 hours at neutral salt-spray.**

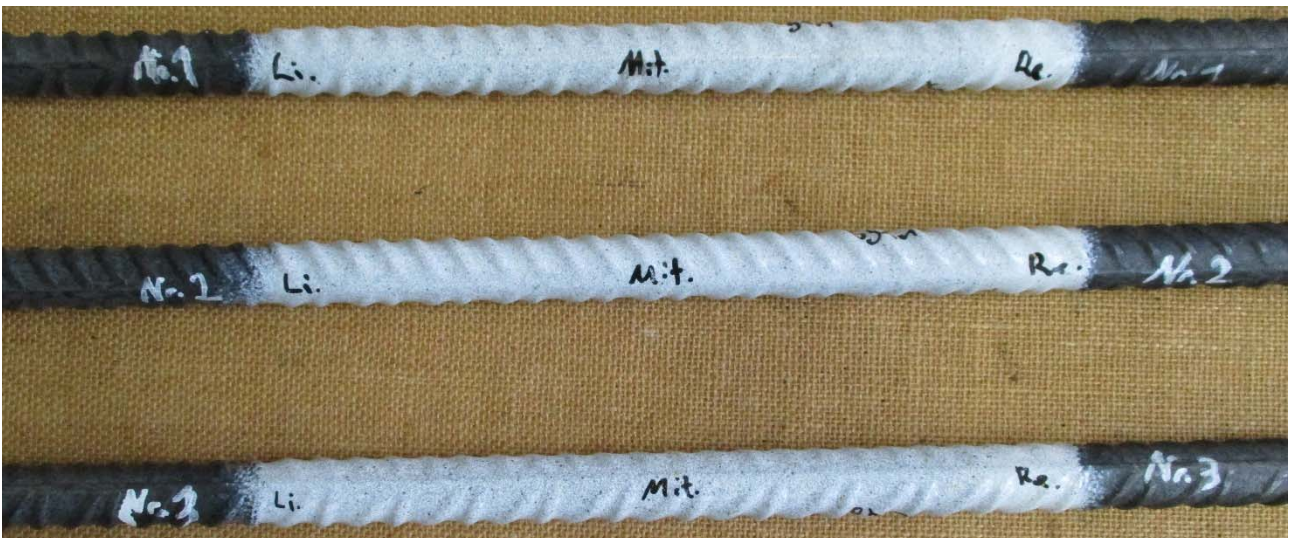
**Picture 5: View of plastic coated area of tie bars before corrosion testing.**

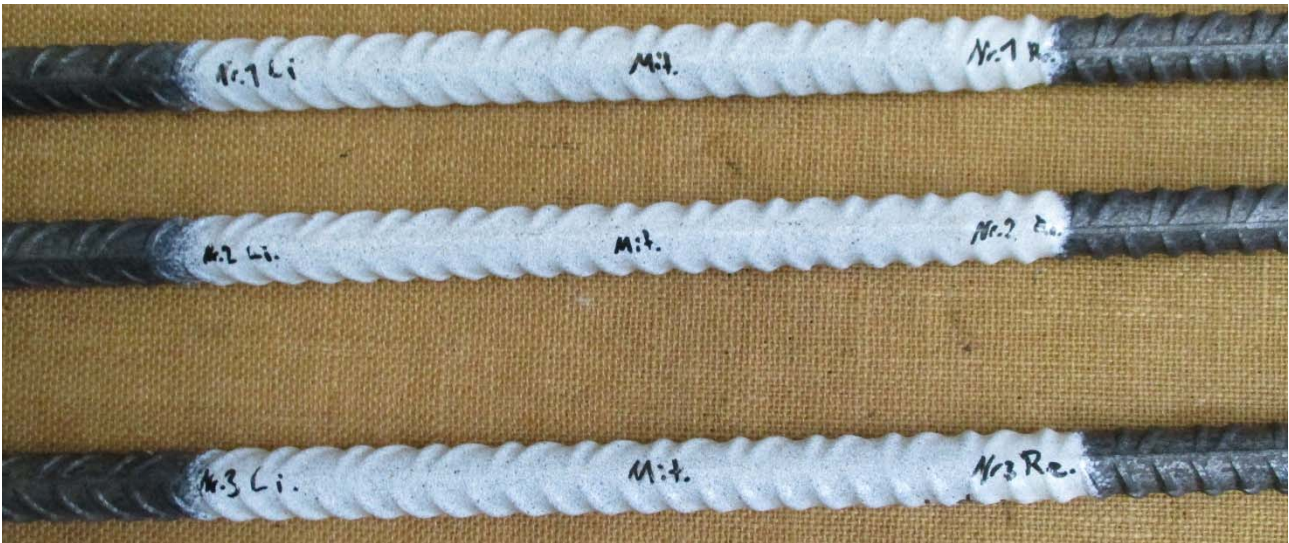
Picture 6: View of opposite side lateral surface of plastic coated area of tie bars before corrosion testing.

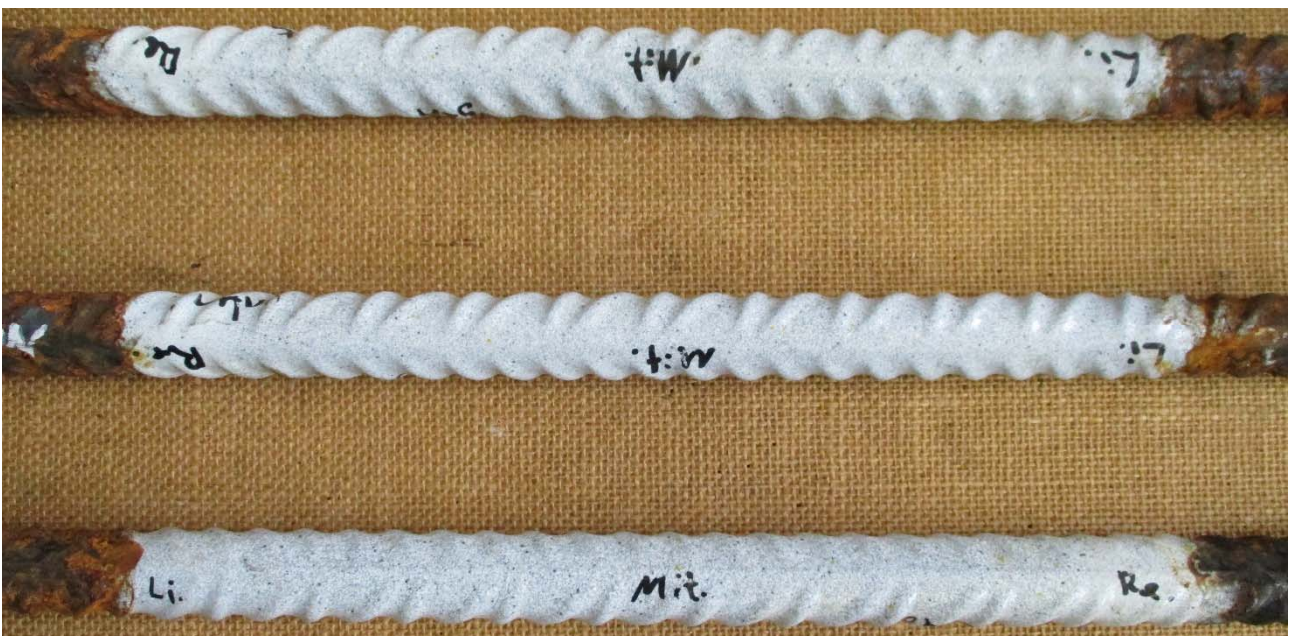
On all three investigated tie bars no rust was observed after 240 hours of neutral salt-spray in regarded area of lateral surface (200 mm length in centre of tie bar). See pictures 5 and 6 for view of tie bars before testing and pictures 7 and 8 for condition of tie bars after corrosion test.

Picture 7: View of plastic coated area of tie bars after 240 hours salt-spray. No rust was observed in regarded area of lateral surface (200 mm in centre of tie bar).

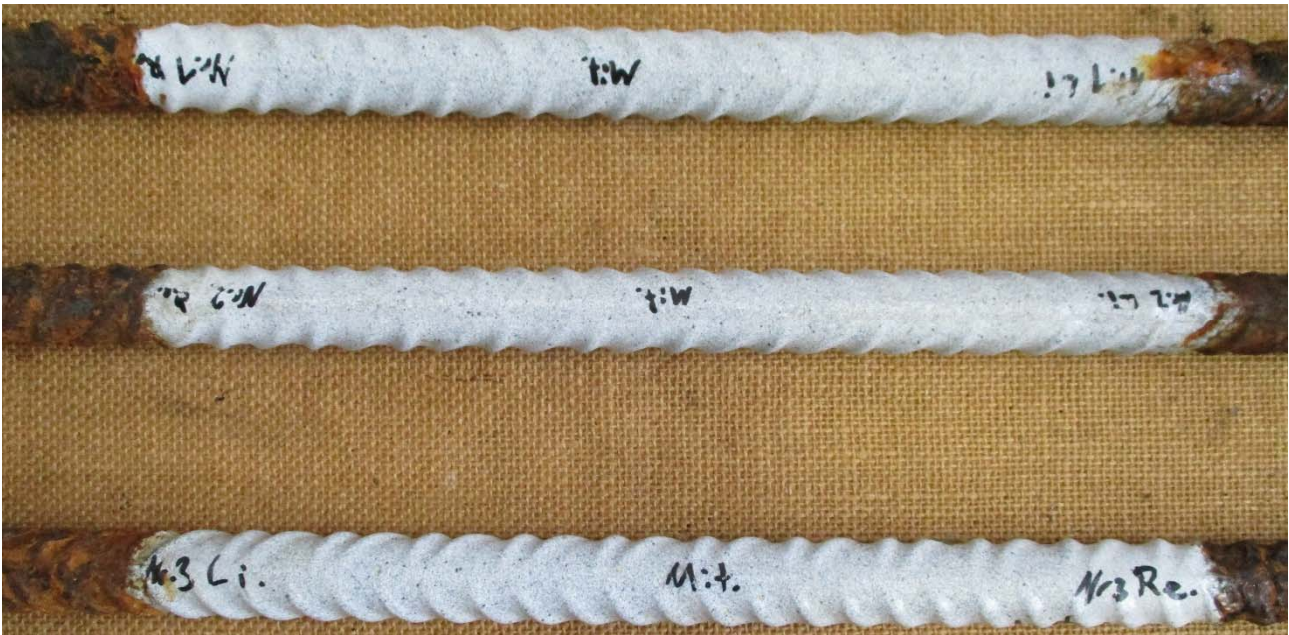
**Picture 8: Opposite view of plastic coated area of tie bars after 240 hours salt-spray. As well, no rust was observed in regarded area of coated lateral surface.**
